Release of suspended sediments during the 2019-2020 drawdown of Morrow Lake (Kalamazoo River, Michigan)

Revised 24 February 2021

Stephen K. Hamilton
Kellogg Biological Station
Michigan State University
hamilton@msu.edu

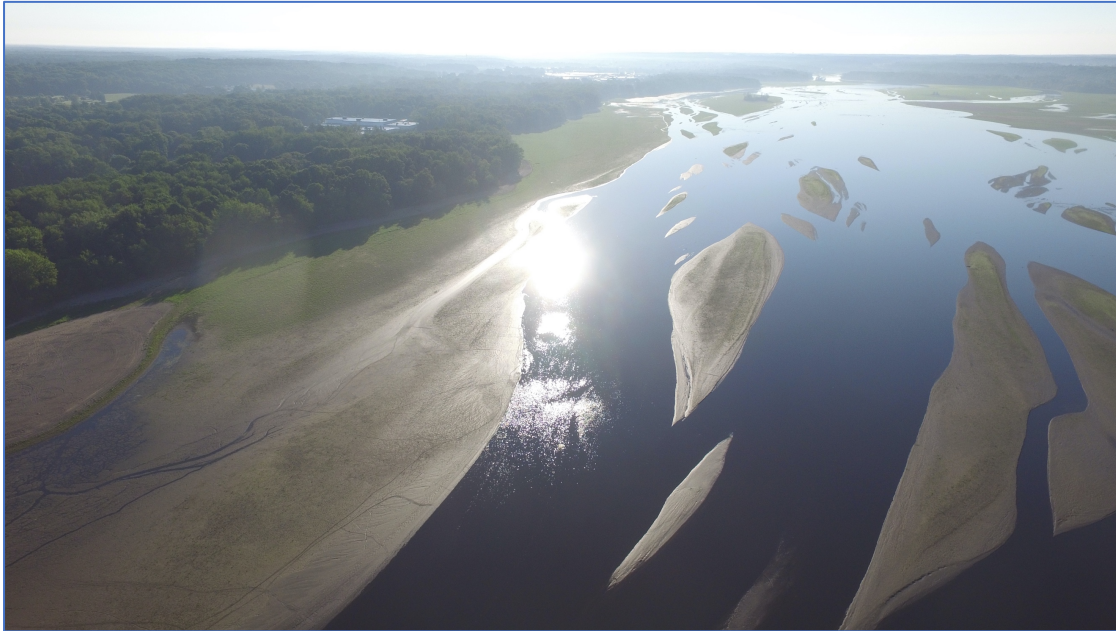
Fig. 4. An aerial view of Morrow Lake looking east from near the dam on 13 July 2020 shows the spatially variable erosion of fine sediments. Photo courtesy of the Kalamazoo River Watershed Council.

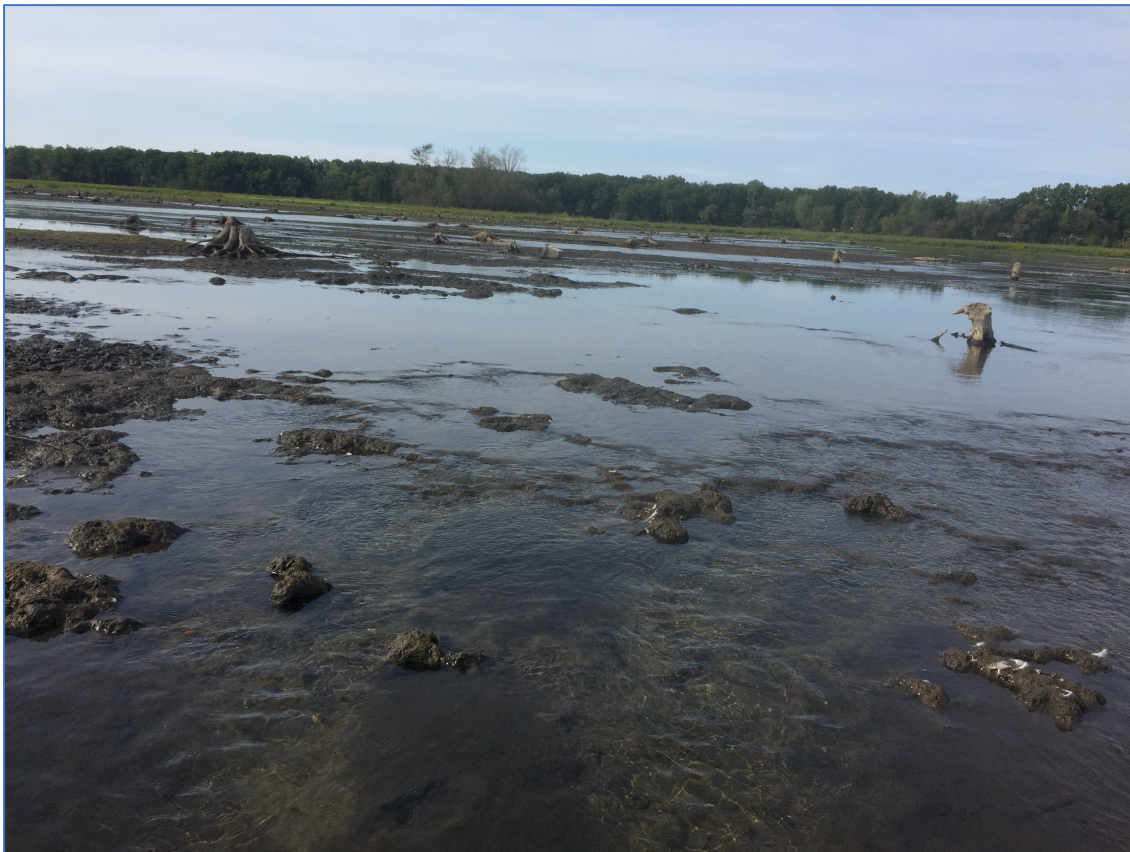
Fig. 5. Stumps and eroding organic sediments became visible during the drawdown (Sep 2020).
